DEVELOPMENT OF ABRASIVE BLADE TIP COATINGS FOR USE IN AN ABRADABLE TURBINE GAS PATH SEAL SYSTEM

United Technologies Corporation
Pratt & Whitney Aircraft Group
Government Products Division
P. O. Box 2691
West Palm Beach, Florida 33402

April 1977

Final Report for Period 1 January 1976 Through 31 December 1976

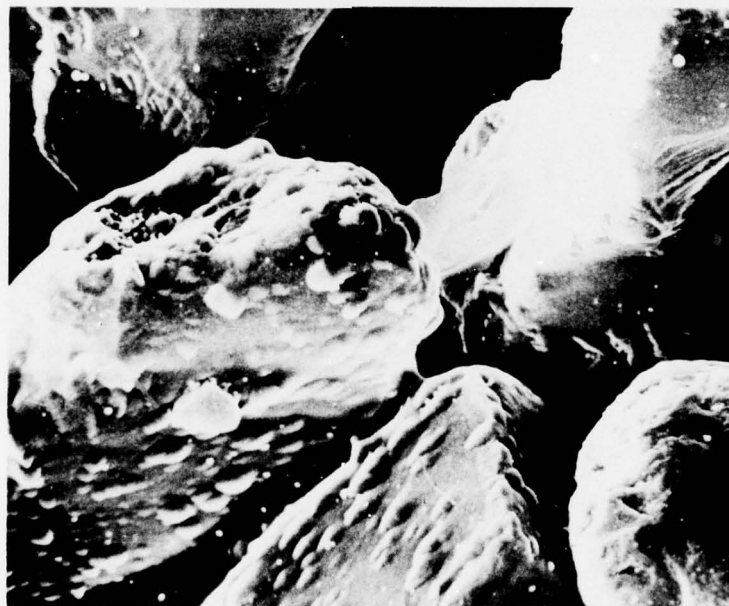
Figure 2. Alumina Coated Silicon Carbide Grains As-Coated From the RF Sputtering Run at 1200°F, 600w, 2-in. Dia. Target for 95 Hr

Samples of the Al₂O₃ coated SiC were sputtered with a gold palladium (AuPd) alloy and examined in the scanning electron microscope: (1) in the as-coated condition, and (2) after mechanically fracturing a sample of the grains. Figure 2 illustrates the alumina coated SiC material in the as-coated condition. Figure 3 illustrates the alumina coated SiC material after being mechanically fractured to observe the coating cross section. The alumina coating shows a typical columnar structure with an average coating thickness of approximately 0.00015 in. (0.15 mil), and a thickness range of 0.0002 to 0.00005 in. (0.2 to 0.05 mil).

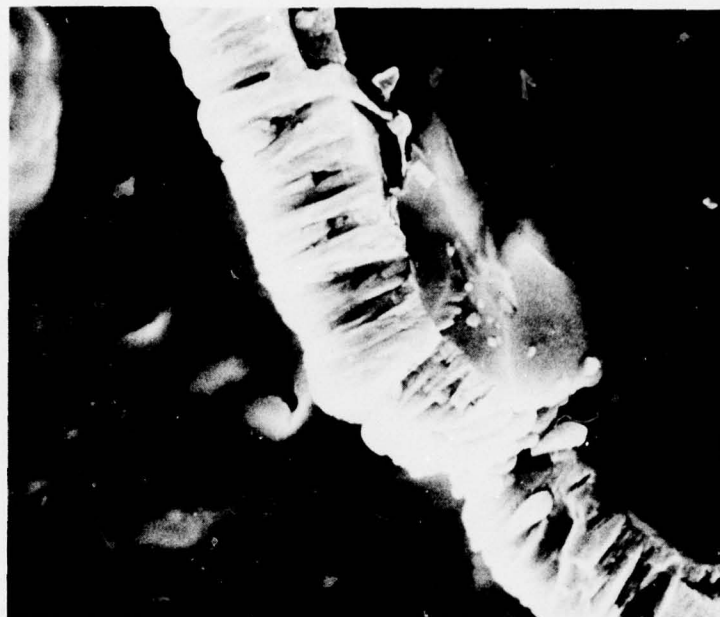
Figure 3. Alumina Coated Silicon Carbide Grains Mechanically Fractured From the RF Sputtering Run at 1200°F, 600w, 2-in. Dia. Target for 95 Hr

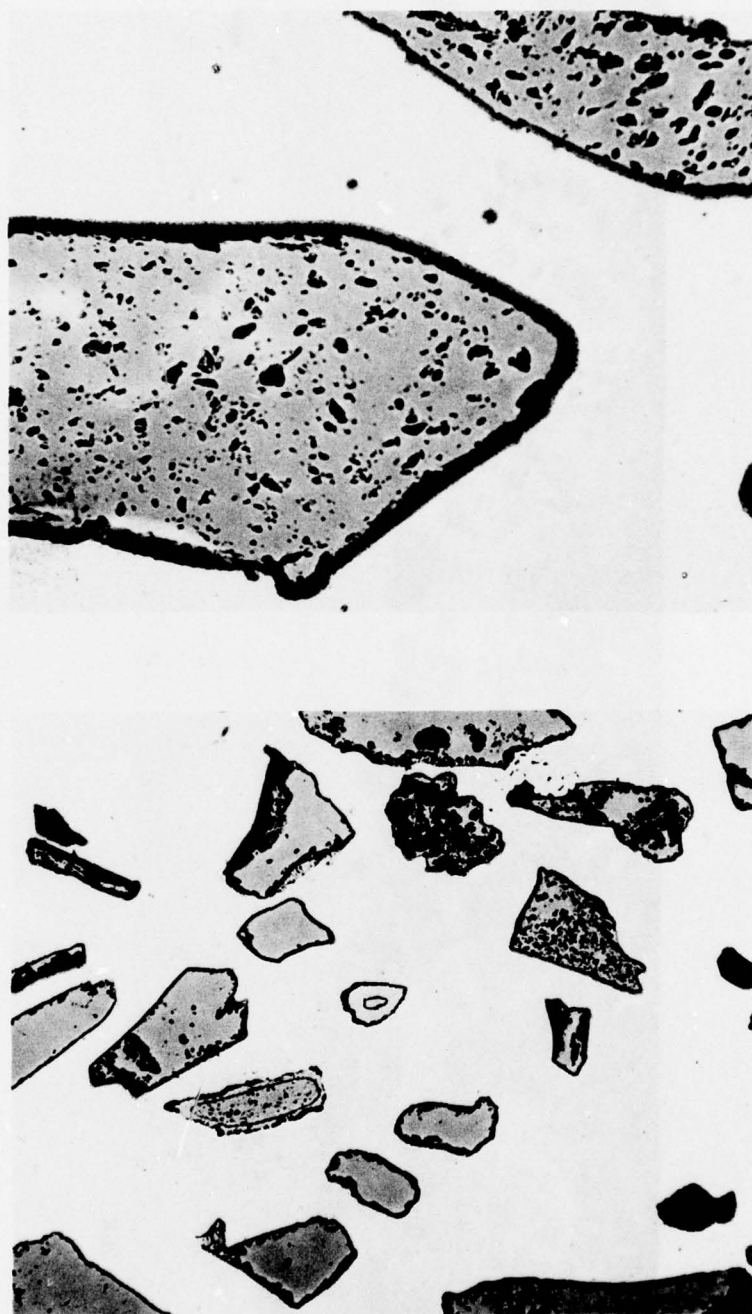
Figure 4. Alumina Coated Silicon Carbide Grains From the RF Sputtering Run As-Vacuum Hot Pressed at 2100°F, 1 Hr, 5 ksi in MERL 711 Co Base Alloy

coating had prevented reaction between the SiC and MERL 711 Co alloy, however, several isolated SiC grains did reveal some dissolution in the MERL 711 Co alloy matrix. A small percentage of the irregularly shaped SiC grains were believed to have geometry-related alumina coating defects which allowed reaction between these SiC grains and the MERL 711 metal matrix. Also, X-ray phase identification was completed on the 1200°F Al₂O₃ sputtered SiC grits. The phases present were: α -SiC and δ -Al₂O₃.

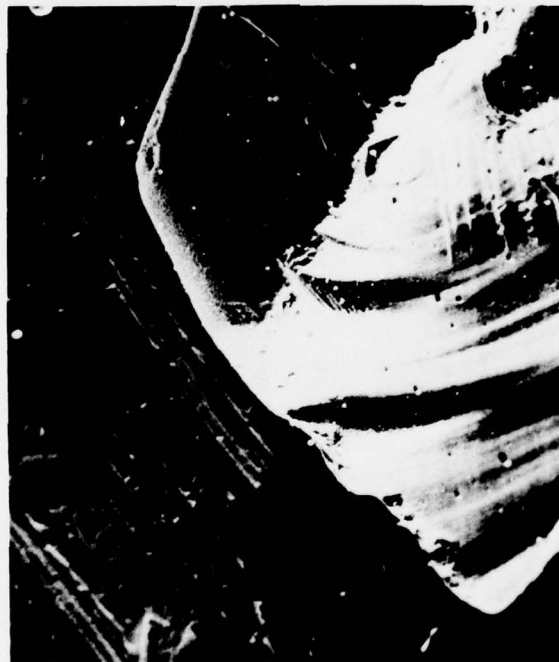
Figure 7. Alumina Coated SiC Grits From the RF Sputtering Run at 1600°F, 600w, 2-in. Dia. Target for 94 Hr

Three grams of 8 mil SiC was sputter coated for a total of 94 hr at 1600°F \pm 25°F. Specimens of the Al₂O₃ coated SiC were examined in the scanning electron microscope: (1) in the as-coated condition, and (2) after mechanically fracturing a sample of the grits. Figure 7 illustrates the Al₂O₃ coated SiC in the as-coated condition. Mechanically fractured grits in the coating cross section are depicted in figure 8. The Al₂O₃ coating revealed a columnar structure similar to the 1200°F RF Al₂O₃ sputtering run but with a somewhat finer grit size. The average coating thickness was approximately 0.00015 in. (0.15 mil) with a thickness range of 0.0002 to 0.0008 in. (0.2 to 0.08 mil), which is essentially the same as the 1200°F RF Al₂O₃ sputtering trial. Thinner coatings, as shown in figure 9, were detected and attributed to grit geometry and/or RF sputtering line-of-sight focus.

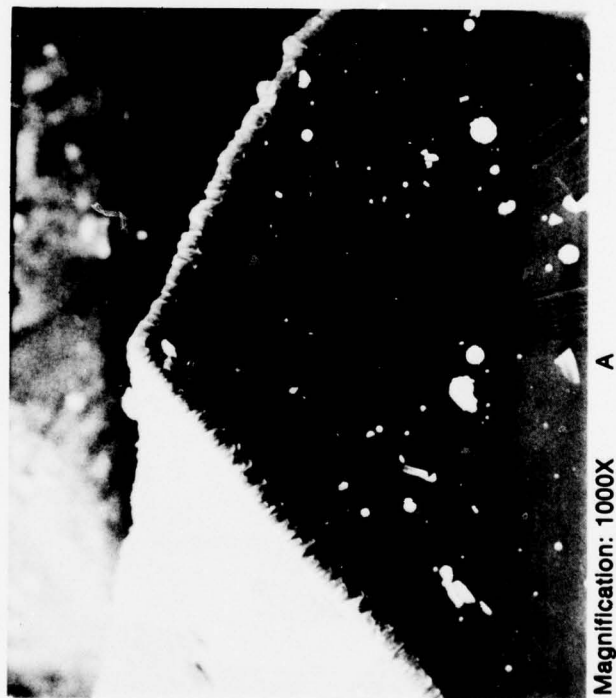
Figure 8. Alumina Coated SiC Grits From the 1600°F Sputtering Run Fractured to Show the Coating Cross Section

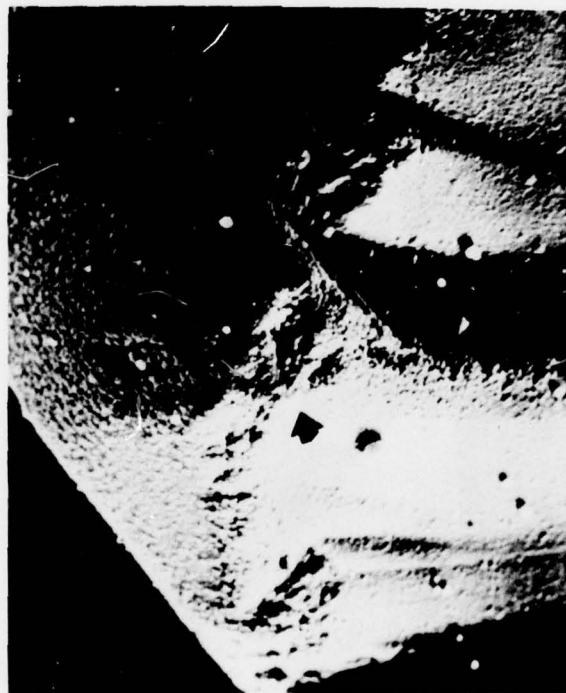
Figure 9. Alumina Coated SiC Grits From the 1600°F Sputtering Run Showing a Geometry-Related Coating Defect

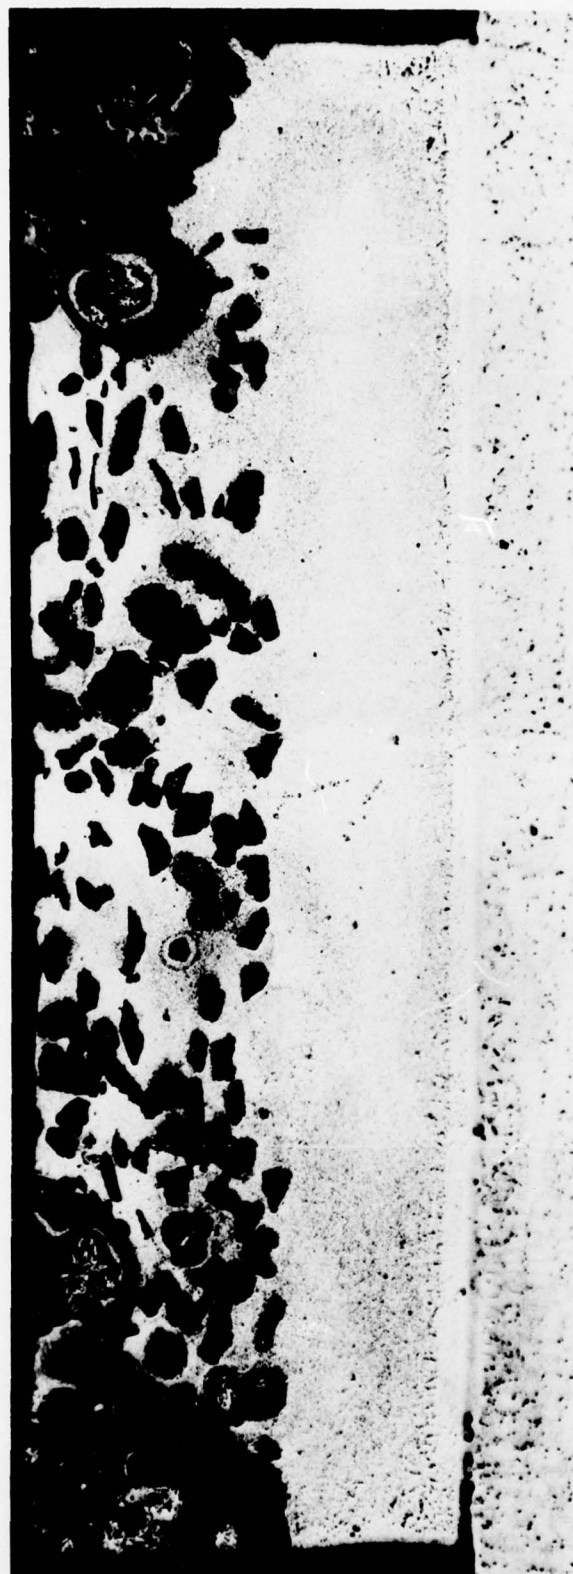
Figure 10. Alumina Coated SiC Grits From the 1600°F RF Sputtering Run as Vacuum Hot Pressed at 2100°F, 1 Hr, 5 ksi in MERL 711 Co Base Alloy

Two specimens of 30% by volume Al₂O₃ coated SiC were also vacuum hot pressed with MERL 711 atomized cobalt alloy powder at 2100°F, 1 hr, 5 ksi in vacuum (10⁻⁴ torr). One specimen was sectioned, metallographically prepared, and examined. Figure 10 illustrates the as-vacuum hot pressed sample of Al₂O₃ coated SiC in the MERL 711 matrix. Aluminum oxide coating prevented dissolution of approximately 95% of the SiC grits in the MERL 711 Co base alloy. The second specimen of the 30% by volume SiC grits from the 1600°F RF sputtered Al₂O₃ run was TLP bonded to a sample of PWA 1422 blade material and solution heat treated at 2200°F for 2 hr. Figure 11 illustrates the TLP bonded and solution heat treated sample cross section. Significantly less SiC had dissolved compared to the 1200°F sputtered run. Figure 12 illustrates several completely dissolved grits adjacent to several unattacked grits and two completely unattacked SiC grits. The appearance of the phases in the dissolved SiC grits appears similar to those analyzed in the 1200°F sputtered run. The edges were more affected than the center as shown in figure 5. The center is only approximately 10% affected as compared to almost all of the SiC grits at the edges. The accelerated dissolution at the edges was thought to be caused by the wetting action of the TLP alloy.

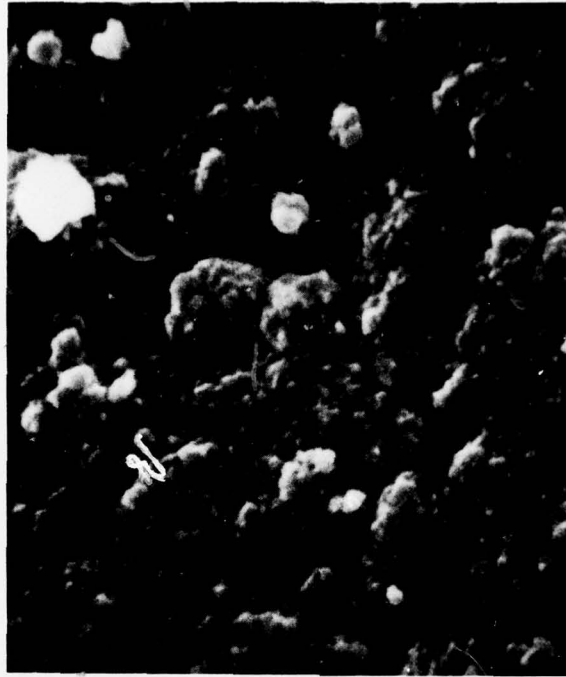
Figure 13. *HfC+ C Coated SiC Grits — Chemical Vapor Deposition Coating*

Numerous attempts were made to deposit HfO₂ on SiC with 100g batches of approximately 8 mil diameter SiC. The repeated attempts consistently resulted in deposition of HfC + C as identified by X-ray diffraction. Abrasive SiC grits coated with HfC + C were examined in the scanning electron microscope: (1) in the as-coated condition and (2) after mechanically fracturing a sample of the grits. Figure 13 reveals the HfC + C coated SiC in the as-coated condition. Mechanically fractured grits within the coating cross section are shown in figure 14. The HfC + C coating had a fine, continuous non-directional structure except for a ridge in the coating which ran parallel to the grit surface about one-third of the way through the coating from the substrate. The ridge in the coating was believed to be the result of two separate coating runs with grits. The average total coating thickness was approximately 0.0003 in. (0.3 mil) with a thickness range of 0.00018 to 0.005 in. (0.18 to 0.5 mil).

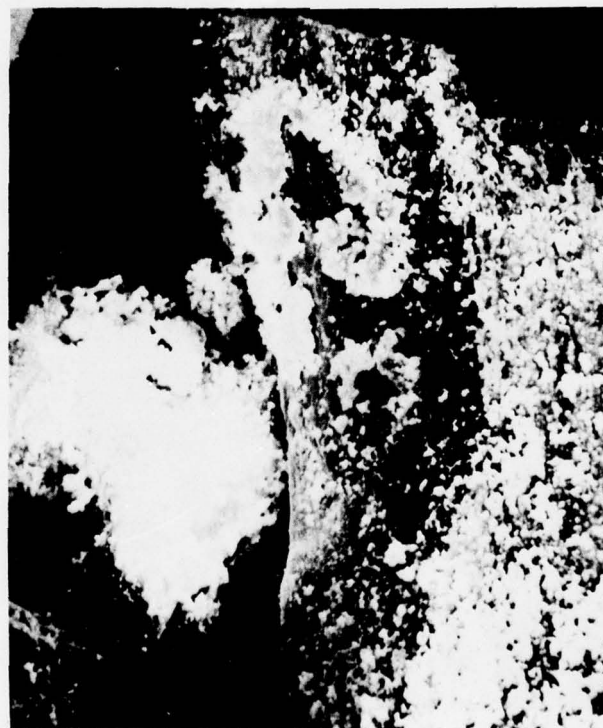
Figure 14. HfC+C Coated SiC Grits — Chemical Vapor Deposition Coating Fractured to Show the Coating Cross Section

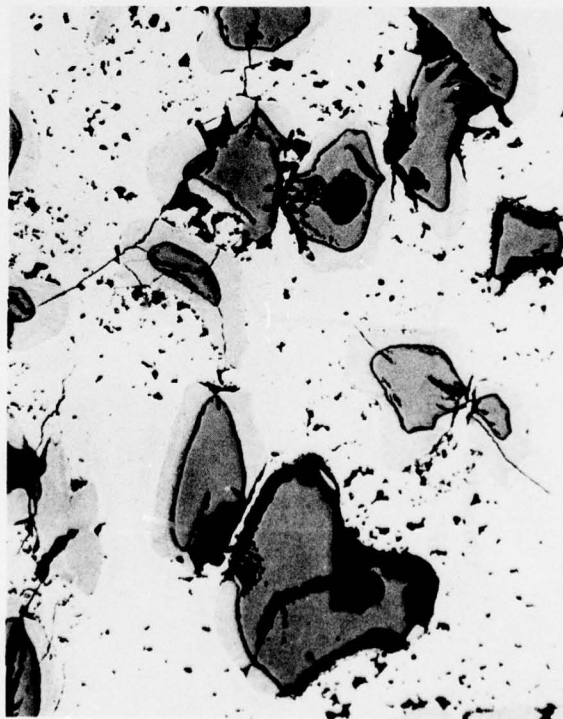
Figure 15. Scanning Electron Microscope Image of Oxidized $\text{HfC}+\text{C}$ Coated SiC Showing Spotty HfO_2 on SiC

A sample of HfC + C coated grits was oxidized in an air atmosphere furnace for 2 hr at 2100°F. X-ray diffraction of the SiC grits from this sample indicated the presence of HfO₂ and β SiC. However, binocular examination of grits from this sample, as shown in figure 15, indicated that the HfO₂ coating was not continuous.

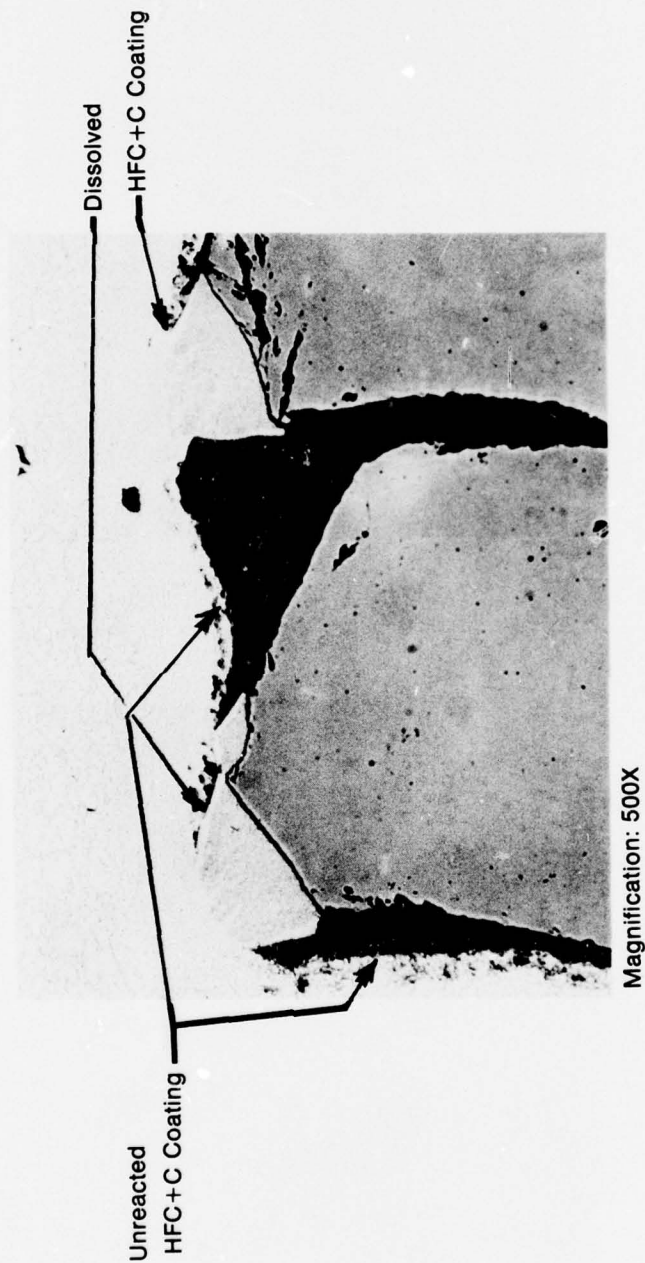
Figure 16. H/C+C Coated SiC Grits as Vacuum Hot Pressed at 2100°F, 1 Hr, 5 ksi in MERL 711 Co Base Alloy

A specimen of 30% by volume HfC + C coated SiC was vacuum hot pressed with MERL 711 atomized cobalt alloy powder at 2100°F, 1 hr, and 5 ksi in vacuum (10^{-4} torr) to assess the effectiveness of HfC + C as a diffusion barrier on the SiC. The specimen was sectioned, metallographically prepared, and examined. Figure 16 illustrates the as-vacuum hot pressed sample of HfC + C coated SiC in the MERL 711 matrix. The coating was only slightly effective in preventing dissolution of SiC in the MERL 711 matrix.

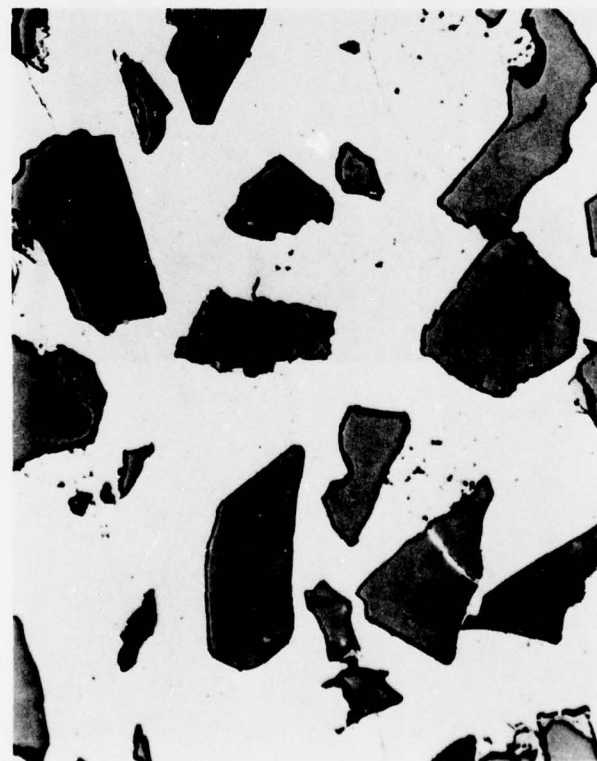
Figure 18. Inverted Image of Area in Figure 17 as Viewed in Scanning Electron Microscope Showing SiC Grit With Reacted and Unreacted HfC+C Coating in MERL 711

Metallurgical and X-ray image analysis determined that more than 95% of the grits reacted with the matrix alloy, MERL 711. A magnified view of a dissolved grit and unreacted grit is shown in figure 17. Figure 18 displays a scanning electron microscope image from which it was determined that the dissolved SiC area had Co, Cr, Si, and Ni as major element constituents. Also the X-ray image results determined that the coating displayed a non-homogeneous composition of HfC and C. Further, Hf was detected at the grit boundary of the dissolved grits which indicates the ineffectiveness of HfC as a dissolution barrier.

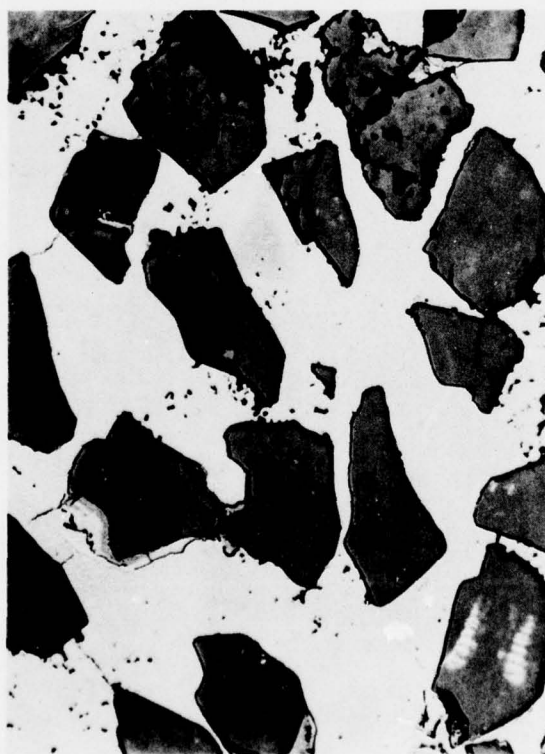
Figure 20. Forty Volume Percent Al₂O₃ Coated SiC Grits Vacuum Hot Pressed in TIPALLOY I™

Tipaloy I[™] Metal
Matrix With
Porosity Evident Al₂O₃ Coating

TIPALLOY I with 30 vol% SiC grits shows minimal porosity (figure 19). However, as the SiC grit volume percent increases to 40 (figure 20) and 50 (figure 21) the porosity increases. The TIPALLOY I matrix contained a fine dispersion of γ' and γ phases with some cracks. Also a minimal reaction of the SiC grits with the TIPALLOY I was observed (figures 20 and 21) which is similar to the SiC grits in MERL 711.

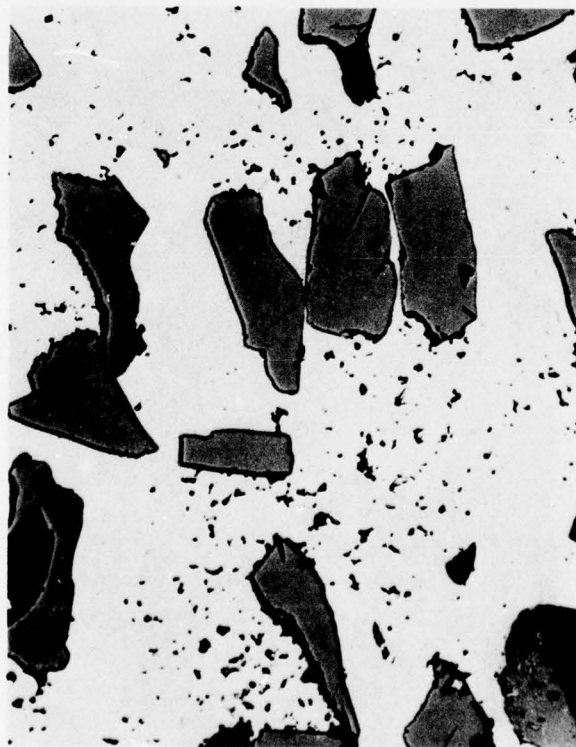
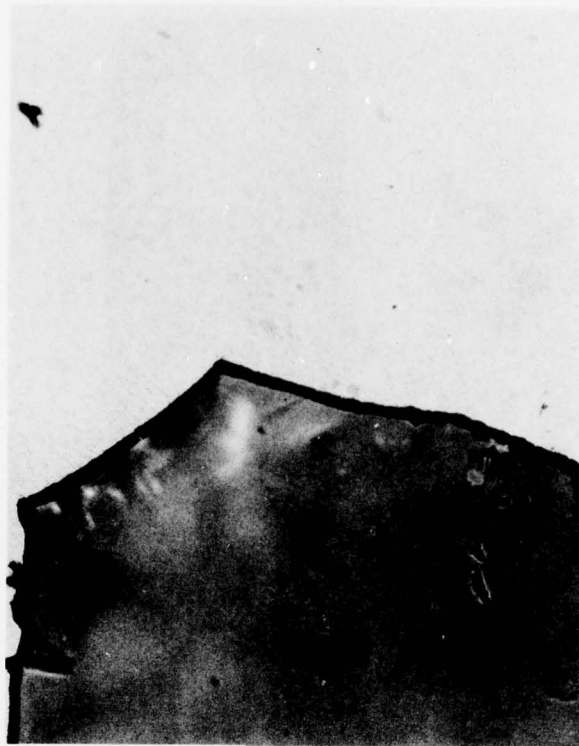
Figure 22. Thirty Volume Percent Al_2O_3 Coated SiC Grits Vacuum Hot Pressed in MERL 72

MERL 72 with the 30, 40, and 50 vol% of SiC grits are shown in figures 22, 23, and 24. The porosity increases with volume percent SiC as with the TIPALLOY I for comparable SiC volume percents. The MERL 72 matrix contains a γ phase with some cracks. No reaction was observed between the SiC grit and MERL 72 which may be attributed to the greater porosity.

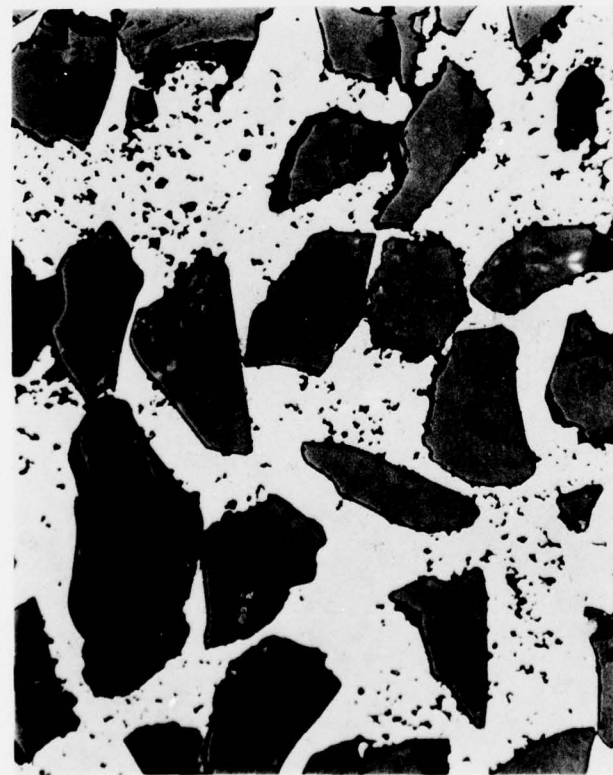
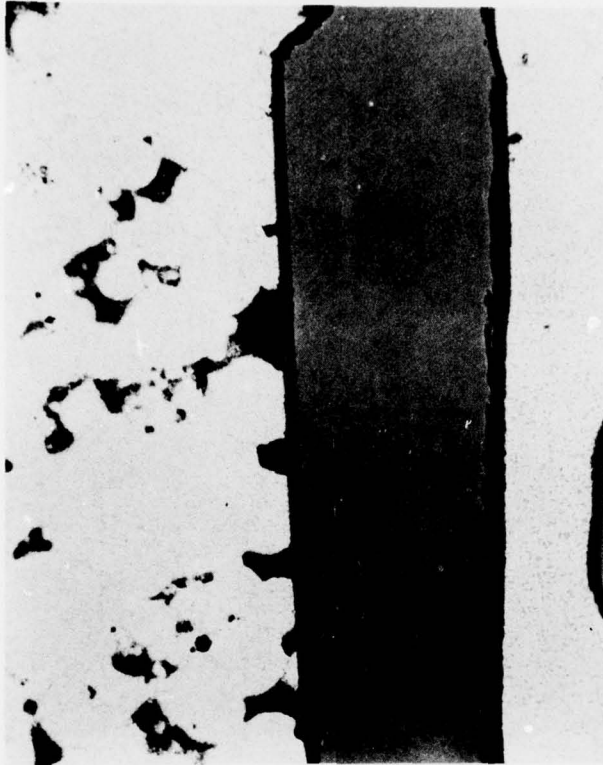
Figure 23. Forty Volume Percent Al_2O_3 Coated SiC Grits Vacuum Hot Pressed in MERL 72

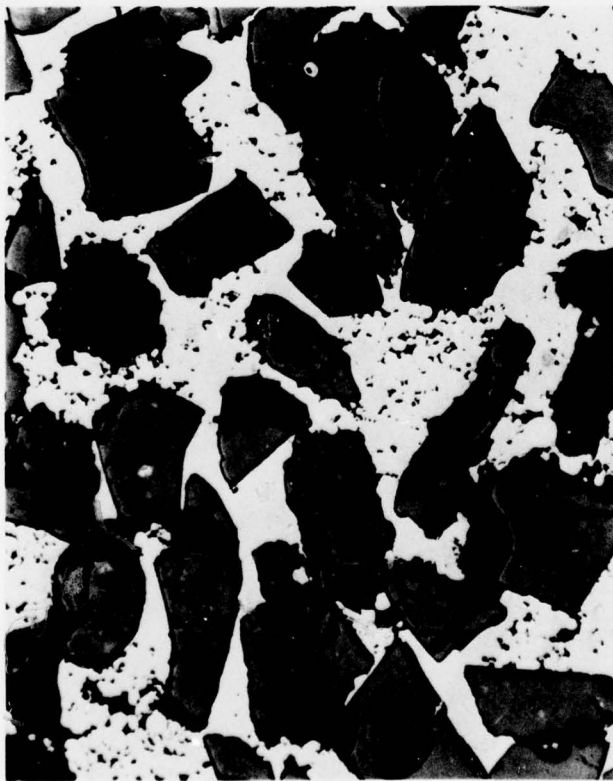
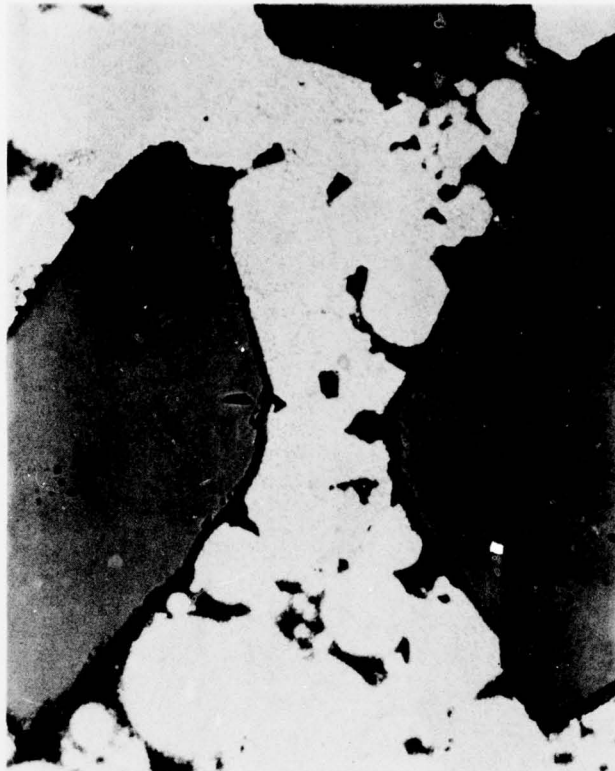
Figure 24. Fifty Volume Percent Al_2O_3 Coated SiC Grits Vacuum Hot Pressed in MERL 72

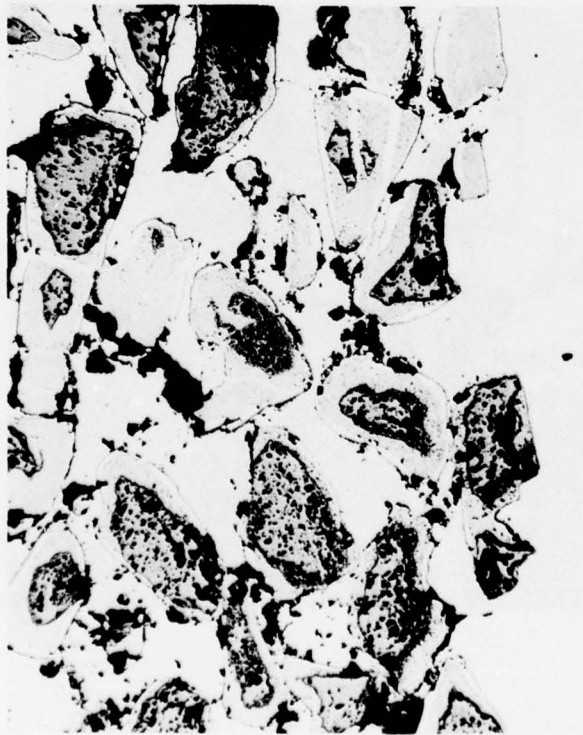
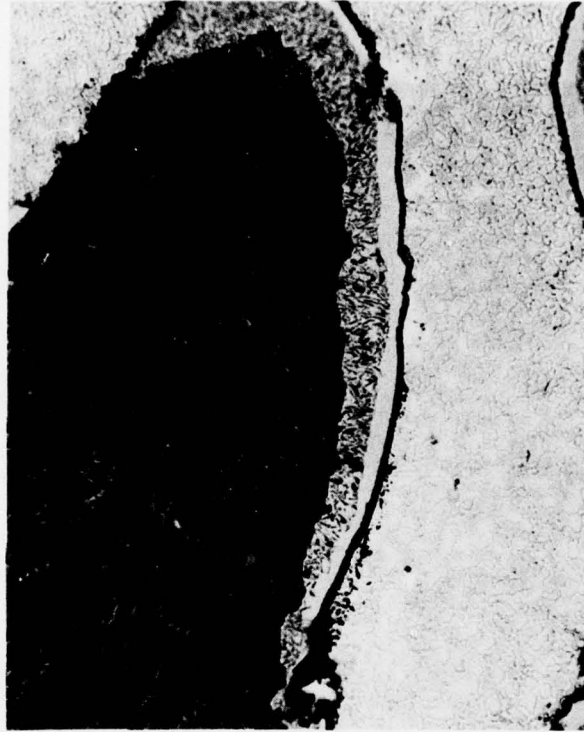
Figure 25. Forty Volume Percent Al_2O_3 Sputtered SiC in MERL 72 TLP₈ Bonded at 2000°F, 8 Hr Showing Minimal Reaction Between the SiC and MERL 72

TLP bond trials were made between metal matrices of MERL 72 and TIPALLOY I containing SiC abrasive grits and PWA 1422 material to select a less stringent TLP cycle than the 2100°F/8 hr cycle. The selected cycle of 2000°F/8 hr showed little if any reaction between the Al_2O_3 sputtered SiC and the MERL 72 (figure 25); however, an extreme reaction between the Al_2O_3 sputtered SiC and the TIPALLOY I was observed (figure 26). No additional reduction in TLP bonding temperature was allowable due to the melting temperature of the TLP foil, therefore, TIPALLOY I was discarded as a candidate matrix material. The MERL 711 specimens, as mentioned previously, exhibited minimal SiC grit dissolution after the TLP bond cycle even after a solution heat treatment at 2200°F for 2 hr.

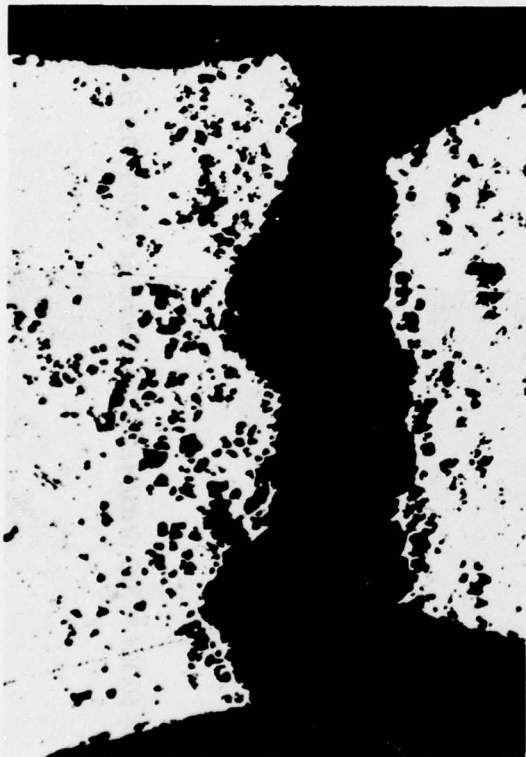
Figure 32. Stress Rupture of MERL 711 at 1800°F, 11.4 Hr

Figure 32 illustrates a microsection of the failed 1800°F MERL 711 specimen which ruptured after 11.4 hr. Secondary cracking is prevalent near the plane of rupture. Figure 33 illustrates the rupture area of the 50 vol% Al₂O₃ sputtered SiC grits in the MERL 711 stress rupture sample which failed after 0.9 hr at 1800°F and 2 ksi.

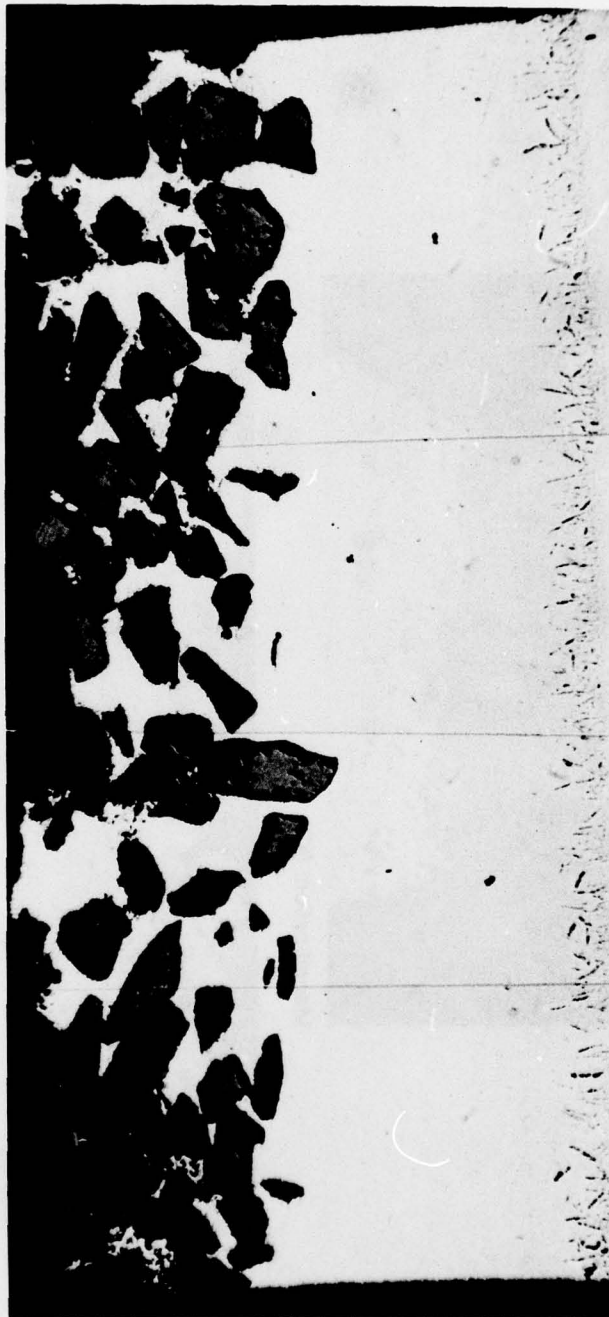
Figure 33. Stress Rupture of 50 Vol % SiC Grits/MERL 711 Matrix at 1800°F, 0.9 Hr

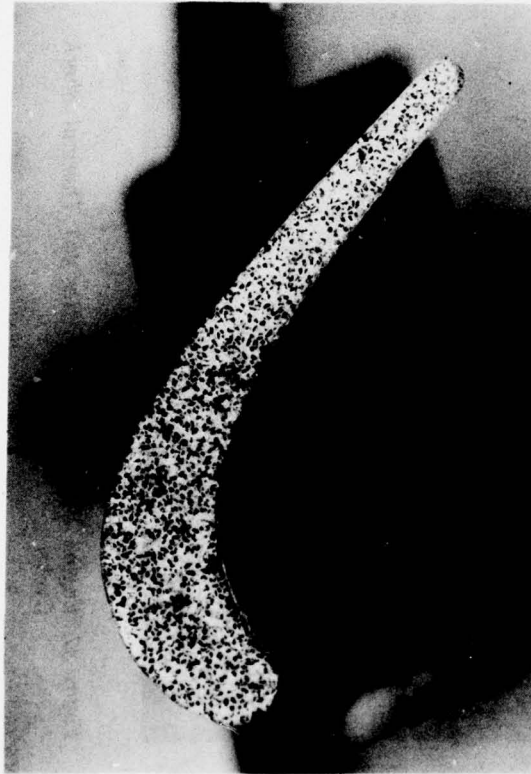
Figure 35. Oblique View Showing Abrasive Coating and Bond on Engine Blade

Two blade tips of 50 vol% Al_2O_3 sputtered SiC in MERL 711 were vacuum hot pressed at 2100°F and 5 ksi for 1 hr. The compacts were machined prior to TLP bonding to the prepared tips of the JT9D (PWA 1422) first-stage geometry turbine blades. The blade tips were then TLP bonded to PWA 1422 turbine engine blades. The resulting bonds were unsatisfactory and exhibited large gaps in the bonds on both sides of the airfoil, particularly at the leading and trailing edges. Scale-up to engine hardware from rig hardware with the 50 vol% SiC grit abrasive produced inadequate positive loading of the leading and trailing edges of the engine blade. Fixturing adjustments were required to produce adequate positive loading of the abrasive tip compact on the engine blade during the TLP cycle. The abrasive tips were remachined and TLP bonded with proper fixturing to new PWA 1422 test blades. The use of a molybdenum cap to apply a uniform positive loading to the blade tips during the bond cycle produced acceptable bonds. The blades were airfoil and tip coated with a protective coating before initiating fluidized-bed thermal fatigue testing. An overall view of the PWA 1422 blade with the tip coating is presented in figure 34. Additional views of the blade tip (figures 35 and 36) illustrate the high concentration and good distribution of abrasive grits in the compact.

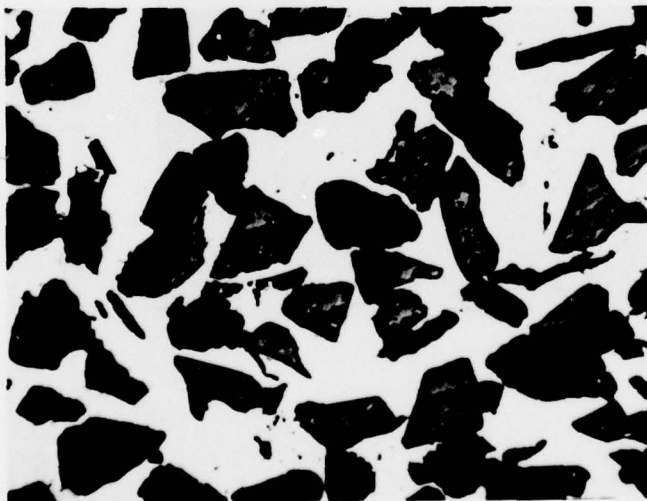
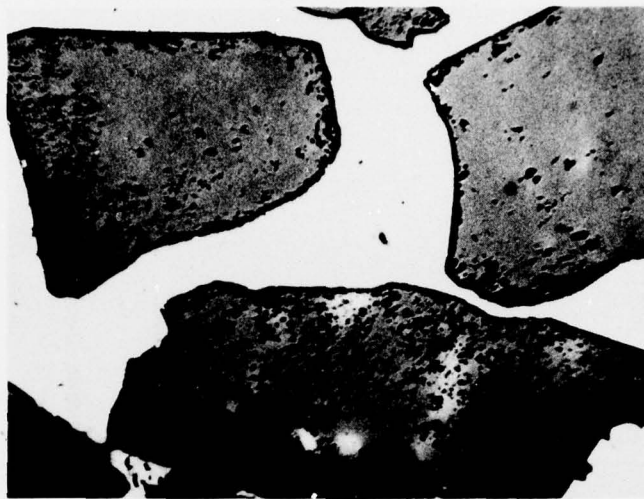
Figure 39. Fifty Volume Percent Al₂O₃ Sputtered SiC in MERL 711 Matrix Showing Good Al₂O₃ Coating and No Grit Reaction

Twelve rig blade tips of 50 vol% Al_2O_3 , sputtered SiC, 8-mil diameter grits in MERL 711 metal matrices were vacuum hot pressed at 2100°F and 5 ksi for 1 hr. Figure 39 illustrates a typical dispersion of Al_2O_3 , sputtered SiC grits at 50 vol% in the MERL 711 matrix. Minimal reaction was observed between the SiC grits and the MERL 711. The tips were machined, pre-oxidized for 1 hr at 2100°F and TLP bonded to PWA 1422 rub rig blades. All rig blades were contoured to remove excess tip material and fluorescent penetrant inspected for bond integrity. Approximately 3 to 4 mils of matrix material was chemically etched from the blade tip surface, thereby exposing only abrasive grits at that location.
